[Docket No. FAA-2021-0872; Project Identifier MCAI-2021-00312-R; Amendment 39-21866; AD 2021-26-07]

Airworthiness Directives; Airbus Helicopters

ACTION: Final rule.

2021-26-07 Airbus Helicopters: Amendment 39-21866; Docket No. FAA-2021-0872; Project Identifier MCAI-2021-00312-R.

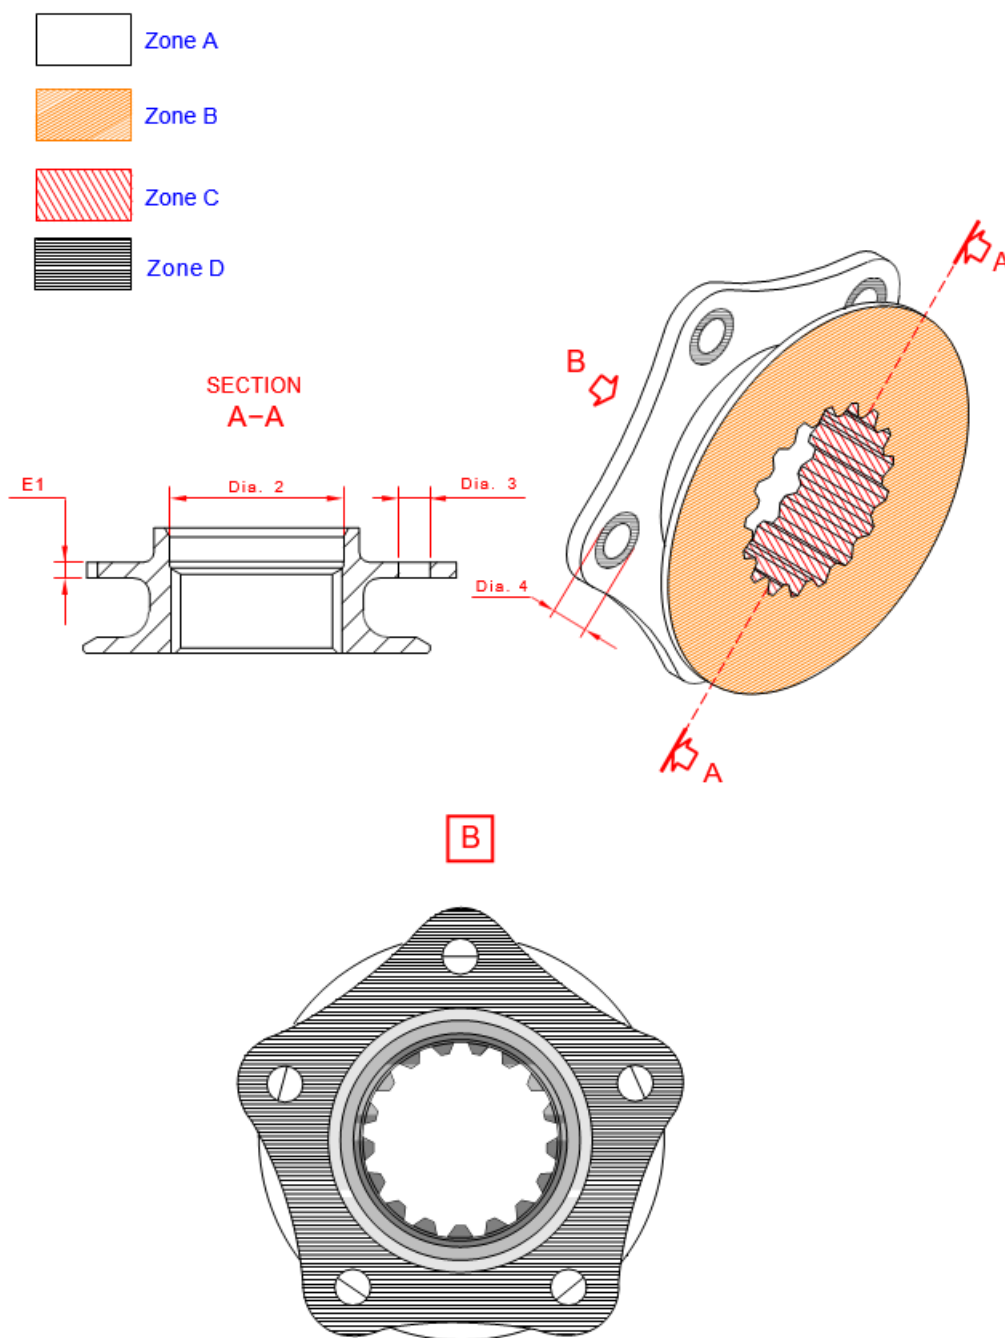
Figure 2 to paragraph (g)(1)(ii) – Inspection Areas of Tail Rotor Splined Flange

(ii) Inspect the TR splined flange for corrosion, impacts, fretting, wear, and a crack in the areas identified in Figure 2 to paragraph (g)(1)(ii) of this AD. If the condition of the part (including corrosion, impacts, fretting, wear, or cracks) exceeds the criteria as specified in Figure 1 to paragraph (g)(1)(ii) of this AD, before further flight, remove the splined flange from service and replace with an airworthy part.

Location as specified in Figure 2 to paragraph (g)(1)(ii) of this AD	Maximum damage, which causes replacement (E1, Dia. 2, Dia. 3, and Dia. 4 are shown in Figure 2 to paragraph (g)(1)(ii) of this AD)
Zone A	Scratch depth > 0.2 mm (0.008 in.). Crack. E1 < 2.75 mm (0.108 in.). Dia. 3 > 6.02 mm (0.2371 in.). Dia. 2 > 33.03 mm (1.3004 in.).
Zone B	Touch-up depth > 0.1 mm (0.004 in.). Crack.
Zone C	Crack. Scratch depth > 0.2 mm (0.008 in.).
Zone D [Dia. 4 = 14 mm +/- 0.1 mm (0.548; 0.555in.)]	Touch-up depth > 0.1 mm (0.004 in.). Crack. E1 < 2.75 mm (0.108 in.).
